# Manhole Inspection Summary

Manhole # S31I2010MH

Insp Date: **12/21/06 9:28 AM**

**Location** Address: **10 GITTINGS AVE**

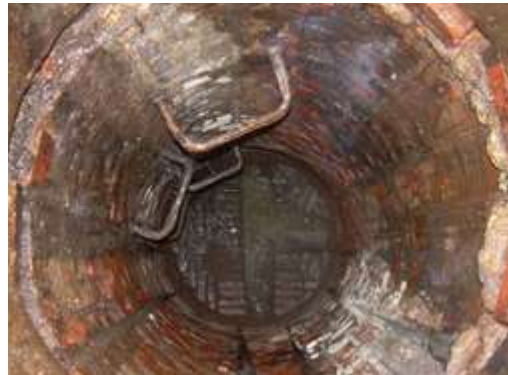
Top View

Corroded steps. Bench debris.

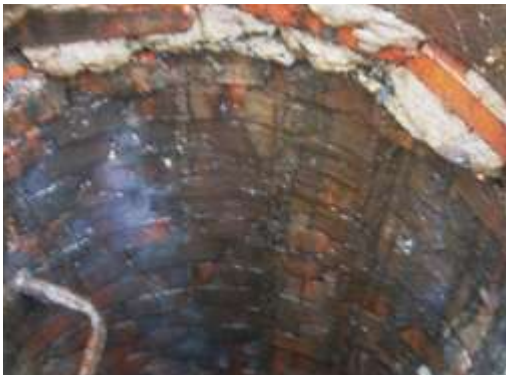
Defect

Frame cracks.

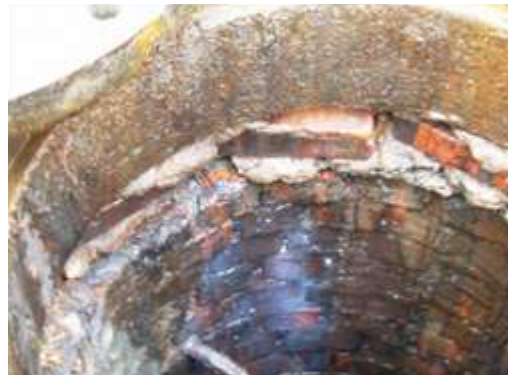
Defect

Frame leaks. Adjustment loose brick, deterioration and infiltration.

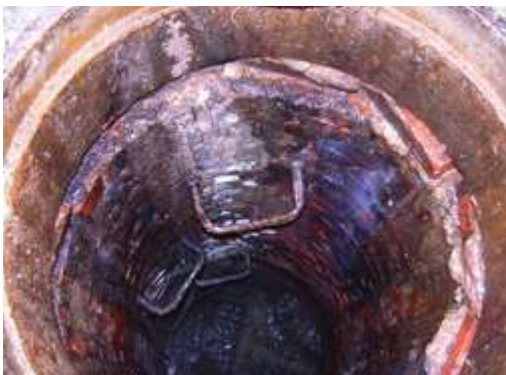
Defect

Frame leaks. Adjustment loose brick, deterioration and infiltration. Corbel and Barrel infiltration.

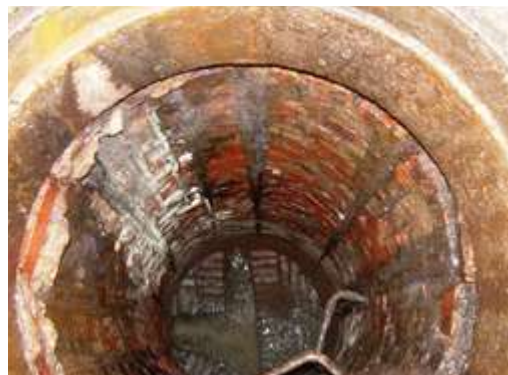
Defect

Frame leaks. Adjustment deterioration and infiltration. Corbel and Barrel infiltration - other side.

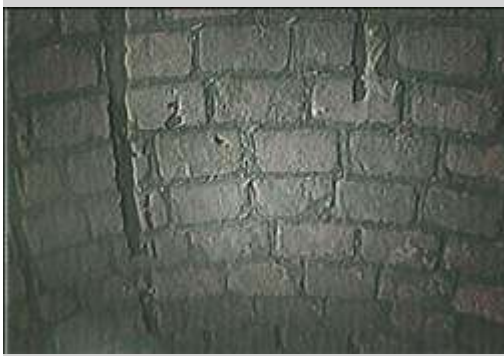
### Defect

Corbel deterioration, root intrusion and infiltration.

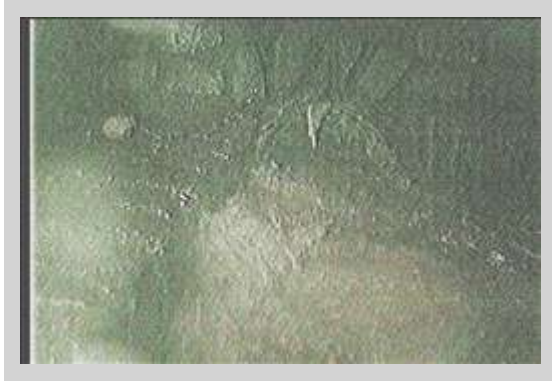
### 8 in. Circular Gravity Sewer Pipe Out @ 12 O'Clock

Infiltration: **Evidence** Pipe Seal Cond: **Unknown**

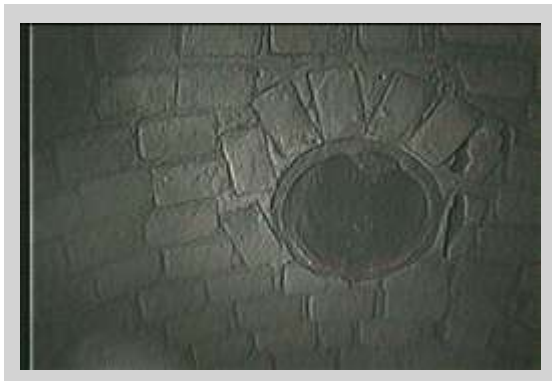
### 8 in. Circular Gravity Sewer Pipe In @ 3 O'Clock

Infiltration: **Evidence** Pipe Seal Cond: **Unknown**

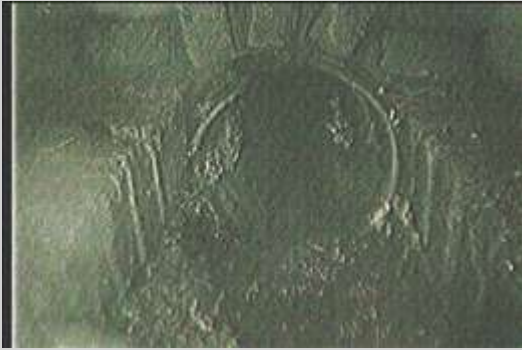
Pipe In @ 6 O'Clock

Channel root intrusion.

Infiltration: **Evidence**

Pipe Seal Cond: **Roots**
